AQUATIC LEASE INSPECTION REPORT

LEASE NUMBER: 22-A02332

USE: COMMERCIAL MARINA

LESSEE NAME: SEVEN Js INVESTMENT LIMITED PARTNERSHIP

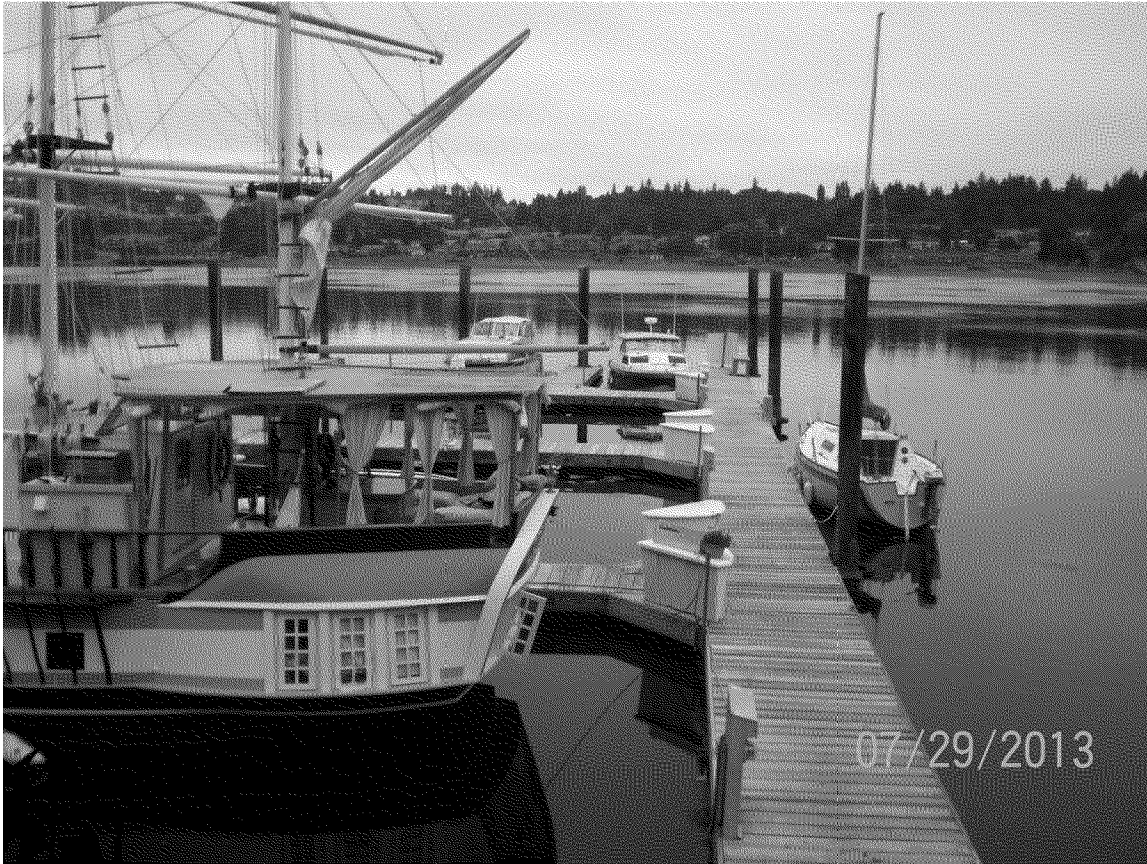
Residential Uses – There are 9 live-aboards in the marina. This number is down from the 36 liveaboards in the marina when the residential use rule took effect. The pump-out is currently not functional. Liveaboards are using the restrooms and showers in the marina office building and taking their boats to the Port of Bremerton to pump-out.

Figure 1 - The pump-out on this dock is not operational.

Jackie said that she requested a repair estimate for the pump-out and filed with the bank to have the repairs done. She thinks someone has made an offer on the marina and the bank would like to hold off on further expenses and have the new owner pick up the cost. – **This needs a follow-up letter requiring conformance to WAC 332-30-171 sewage disposal.**

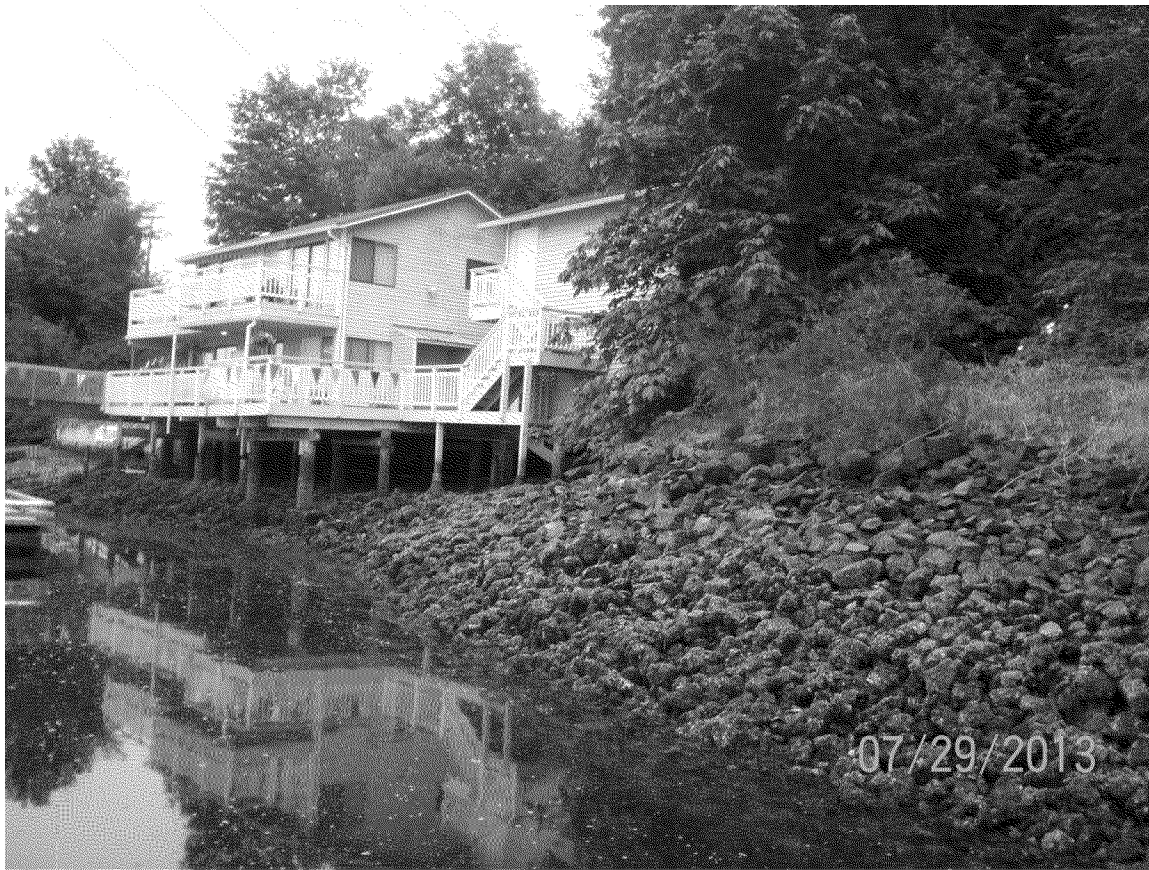
TYPE	CONDITION	DESCRIPTION
FLOATS	FAIR	WOOD DECKING; FLOATATION MATERIAL VAIRIES – PREDOMINATE FLOATS ARE DR. PEPPER PLASTIC BARRELS FILLED WITH FOAM; & CONCRETE;
PILES	FAIR	61 CREOSOTE PILES + THE PILES UNDER THE PIERS
PARKING LOT	GOOD	PARKING LOT ON FILL. THE ASPHALT IS IN GOOD CONDITION (STATE OWNED)
BULKHEAD	*	CONCRETE BULKHEAD – NO OBVIOUS SIGNS OF DETERIORATION (STATE OWNED)
RIP RAP	*	ANGULAR ROCK – IN SOME PLACES IT APPEARS TO BE A SURFACE TREATMENT

THE BUILDING IS CONSTRUCTED ON
FILL AND A PIER. THE CONDITION OF
THE BUILDING WAS NOT ASSESSED.

Figure 2 - Photo shows the marina offices and rip-rap along the shoreline.

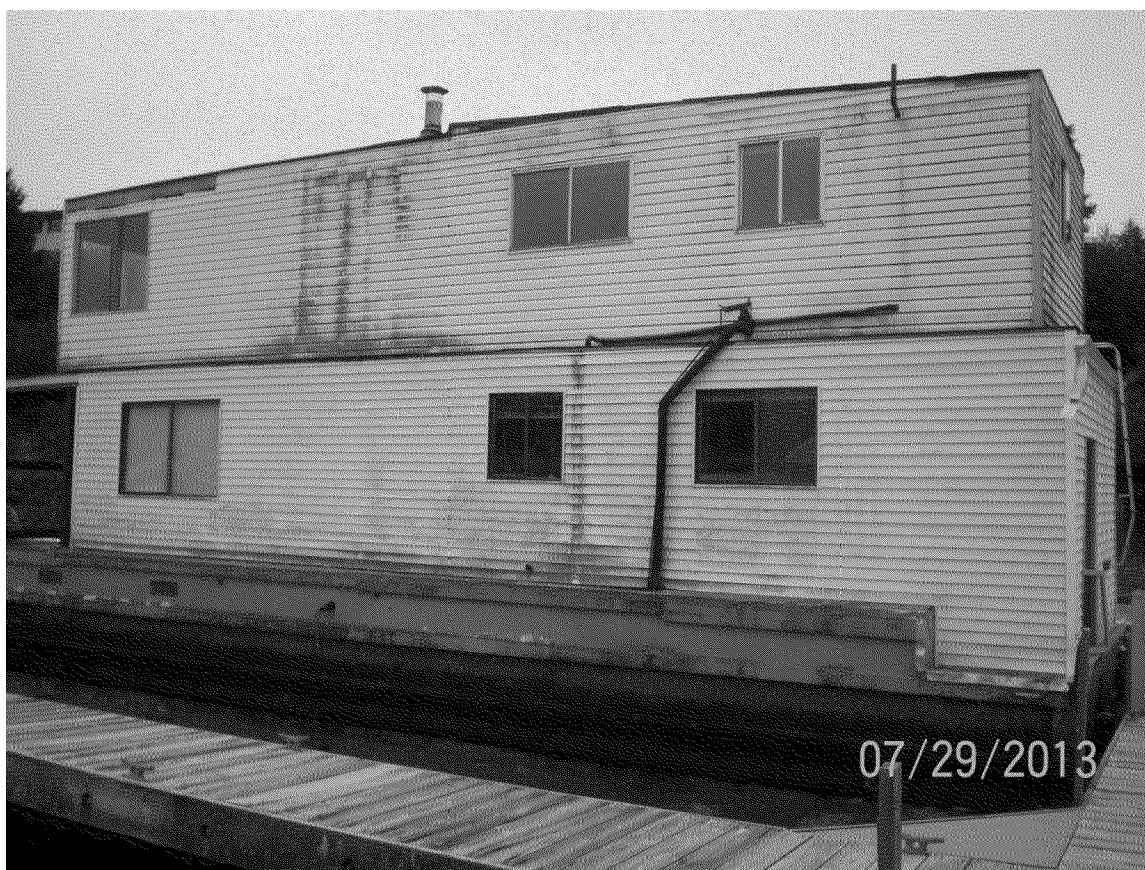
FLOATING HOME POOR

Figure 3 Derelict Floating Home - now in possession of the marina.

Floating Home – Floating homes are not allowed uses within harbor areas. The marina took control of the floating home and tried to auction the home off. No one was interested. They are going to scope out the cost for demolition. I said that no one will be allowed to live on board the floating home. It will continue to be charged NWD rent until it is gone. They should let DNR know when it is demolished.

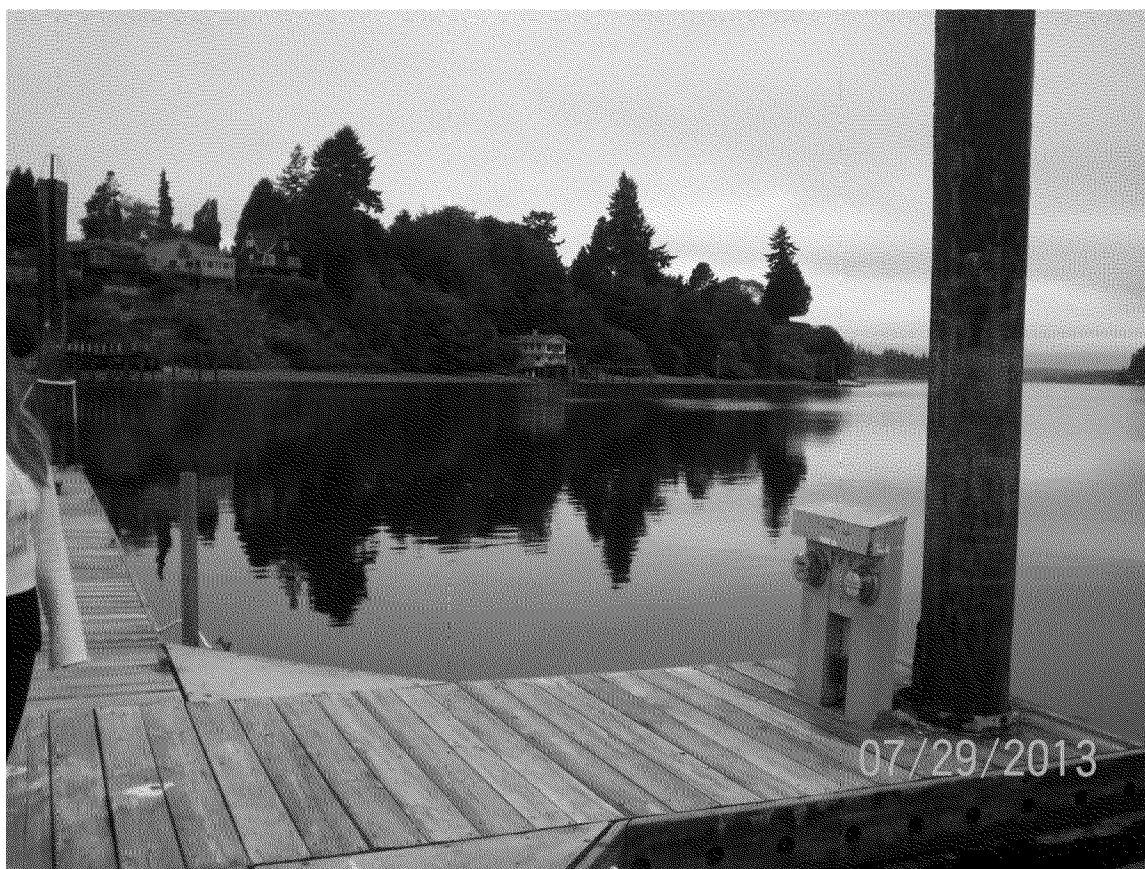
Outer Harbor Line: State Constitution and law do not allow DNR to rent the area outside the outer harbor line to private entities. Some of the marina improvements are shown extending beyond the outer harbor line. The marina had been mooring vessels outside the outer harbor line. – All of the vessels which had been beyond the outer harbor line had been moved inside the outer harbor line.

Figure 4 - Photo showing the outer harbor line. No vessels moored outside the outer harbor line.

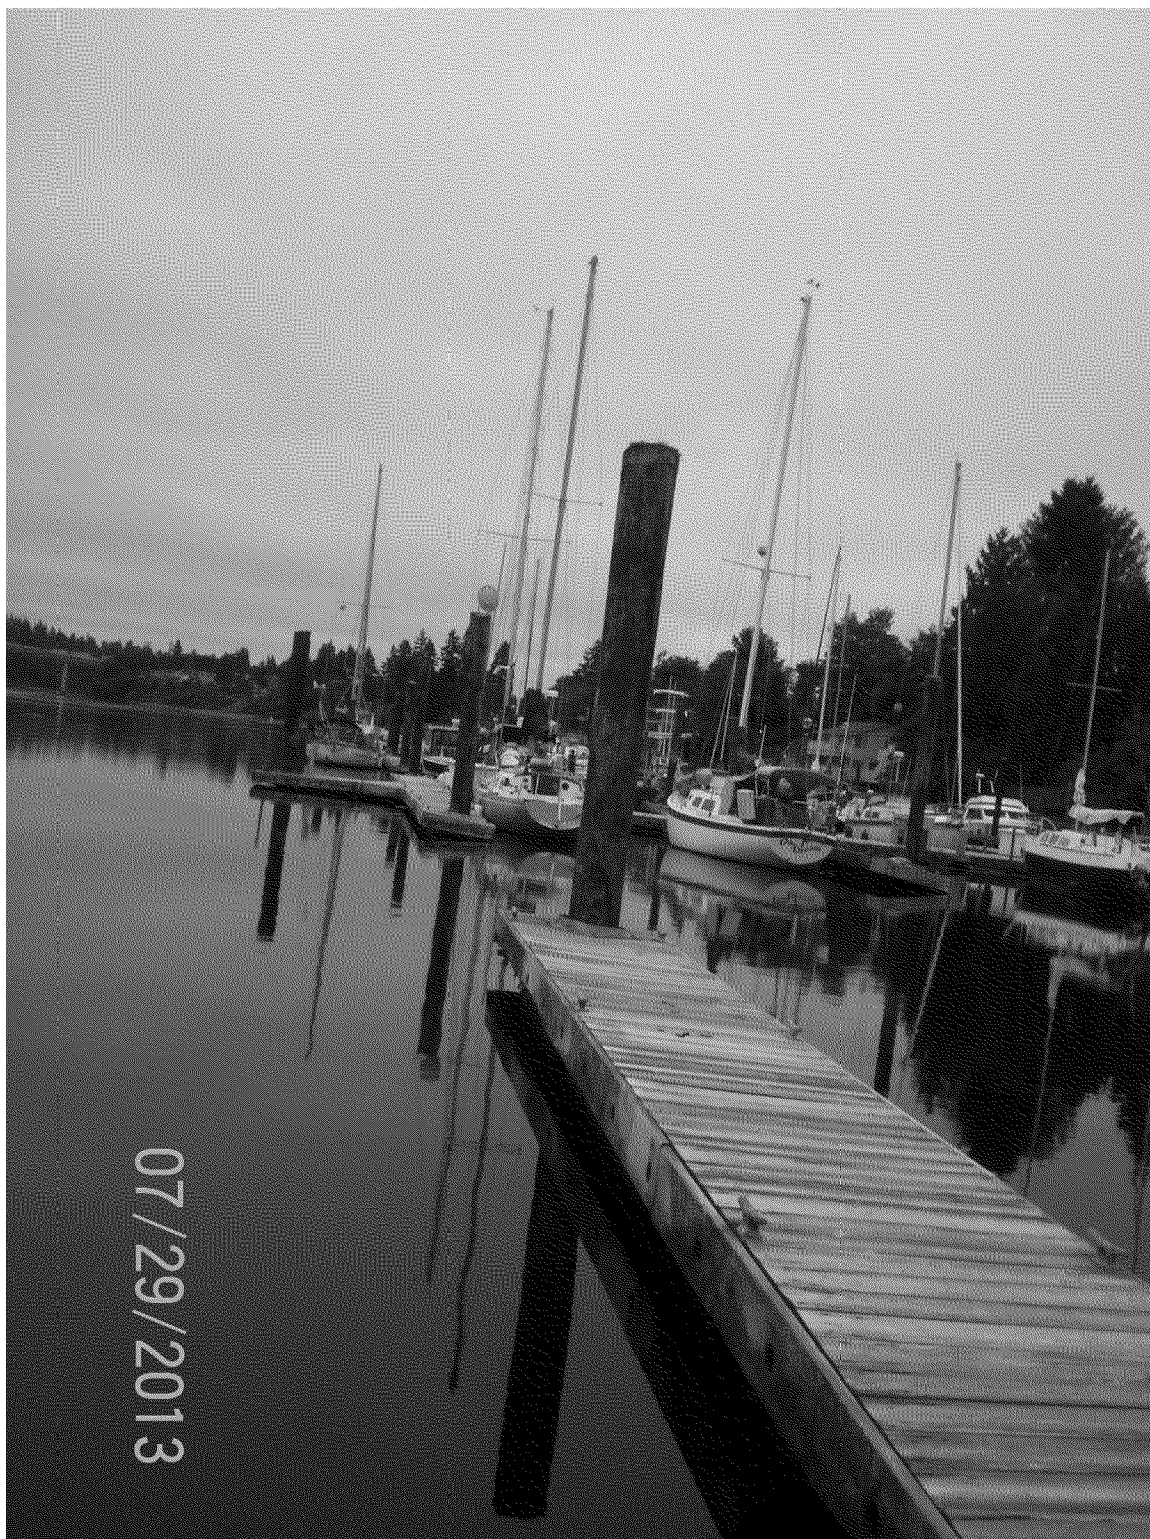
Figure 5 - Photo showing the outer harbor line. No vessels currently moored outside the outer harbor line.
